**Flood Control Project Maintenance
Levee Inspections**

Fall 2013 Levee Maintenance Deficiency Summary Report

Fall 2013 Levee Inspection Results

Reclamation District No. 0544 Upper Roberts Island

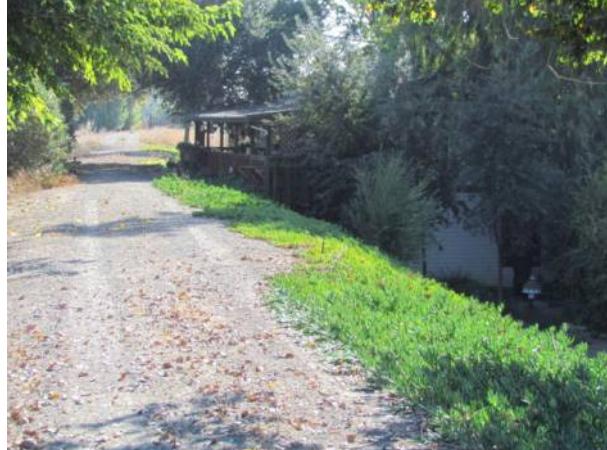
Levee Mile Report Line	11
Start Levee Mile	0.65
End Levee Mile	0.70
Location	Land Side
Category	Earthen Levee
Item	Vegetation
Looking south at landscaping on landward slope.	
richard_f_20131030_137.JPG

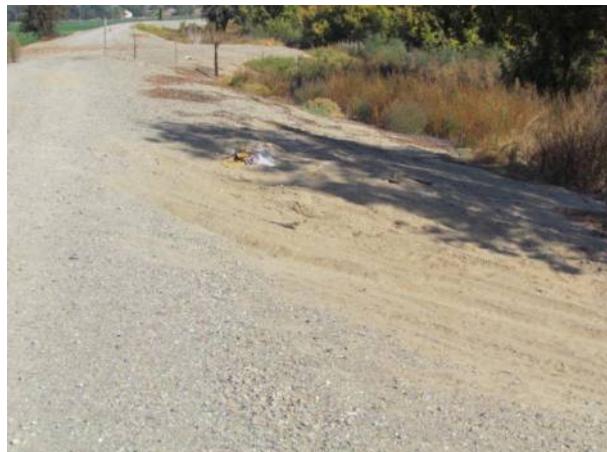
Levee Mile Report Line	21
Start Levee Mile	1.56
End Levee Mile	1.56
Location	Water Side
Category	Earthen Levee
Item	Slope Stability
Looking northeast at waterward slope.	
richard_f_20131030_138.JPG

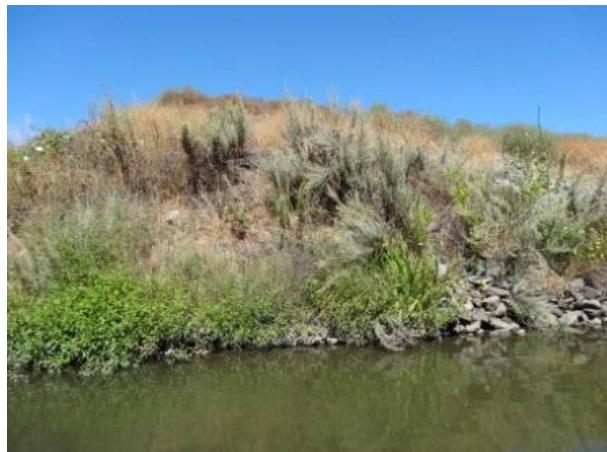
Levee Mile Report Line	29
Start Levee Mile	2.01
End Levee Mile	2.01
Location	Water Side
Category	Supplemental
Item	DWR Erosion Survey
Front view of erosion.	
SJR2013_RD0544U01RM48.81_3.jpg

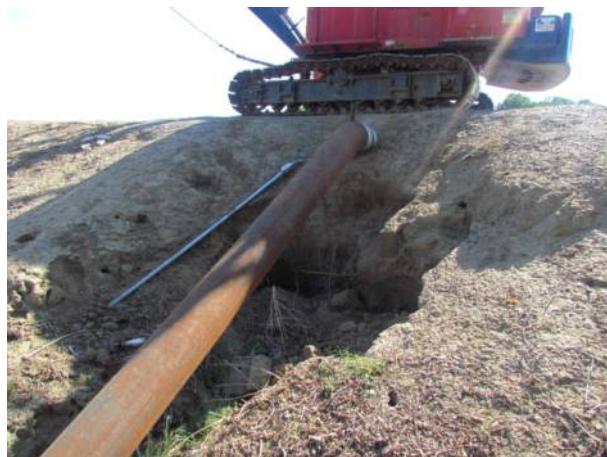
Levee Mile Report Line	30
Start Levee Mile	2.28
End Levee Mile	2.28
Location	Land Side
Category	Earthen Levee
Item	Erosion / Bank Caving
Looking east at erosion under irrigation pipe on landside slope.	
richard_f_20130930_938.jpg

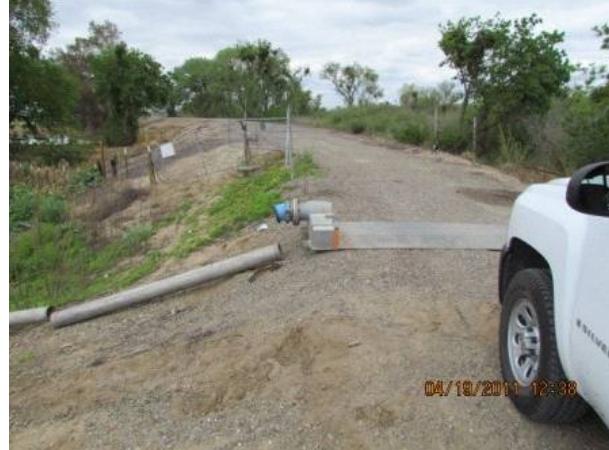
Inspector Comments: Landowner installing temporary irrigation system across levee crown without permit. Pipe is leaking and causing erosion on waterside slope and berm.	-121.318370 °	-121.318370 °	Y	
										DWR ID: DWR_RD0544_01_s_2012_16	
44	2.98	2.98	Earthen Levee	Erosion / Bank Caving	WS Ma	M	E2 : Schedule repair of erosion site prior to the next inspection.	°	°	75	
							Inspector Comments: Hole on levee crown shoulder. Hole is 16"x18"x24. Hole is undermining back toward landward slope.	°	°	Y	
										DWR ID: DWR_RD0544_01_f_2013_75	
45	3.15	3.15	Earthen Levee	Slope Stability	WS Ma	M	S1 : Repair slope instability.	37.837929 °	37.837929 °	76	
							Inspector Comments: Slope damaged extends from levee slope to shoulder.	-121.317663 °	-121.317663 °	Y	
										DWR ID: DWR_RD0544_01_f_2013_76	
46	3.19	3.19	Earthen Levee	Slope Stability	WS Ma	M	S2 : Repair the levee slope damaged by foot traffic and prevent access where possible.	37.837530 °	37.837530 °	62

Levee Mile Report Line	43
Start Levee Mile	2.98
End Levee Mile	2.98
Location	Land Side
Category	Earthen Levee
Item	Encroachments
Looking north at pipe and pipe ramp on landside and crown of levee.	
richard_f_20130930_931.jpg

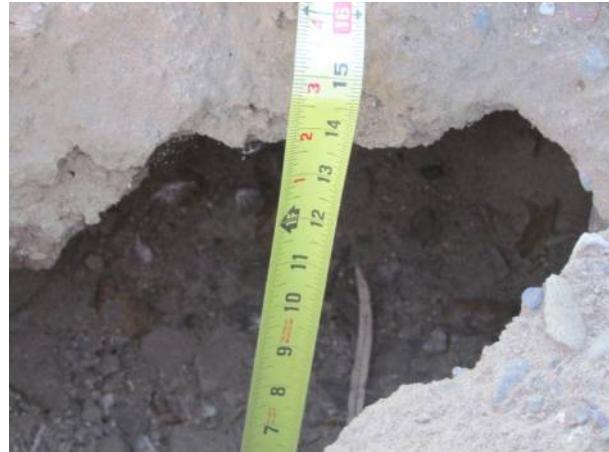
Levee Mile Report Line	44
Start Levee Mile	2.98
End Levee Mile	2.98
Location	Water Side
Category	Earthen Levee
Item	Erosion / Bank Caving
Looking at hole approx. 16" deep on waterward shoulder.	
richard_f_20131030_142.JPG

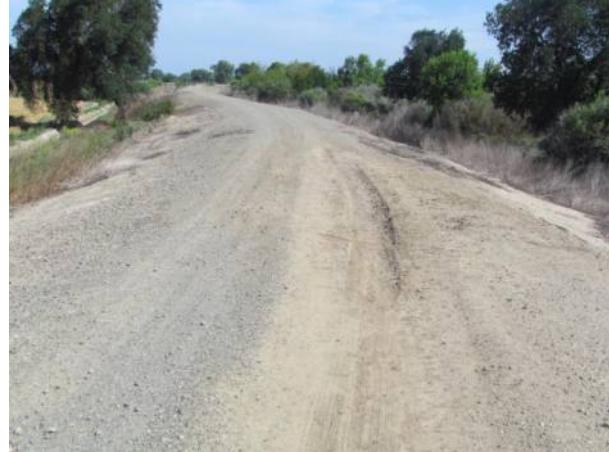
Levee Mile Report Line	54
Start Levee Mile	3.97
End Levee Mile	4.34
Location	Crown
Category	Earthen Levee
Item	Crown Surface / Depressions / Rutting
Looking south at one of several sites needing gravel or road base on levee crown.	
richard_f_20130930_959.jpg

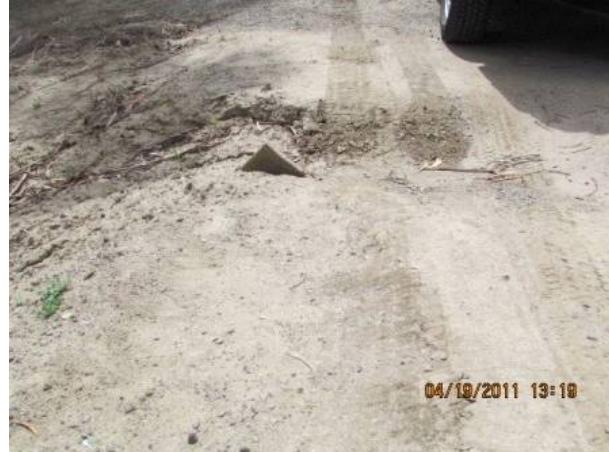
Levee Mile Report Line	62
Start Levee Mile	4.33
End Levee Mile	4.33
Location	Crown
Category	Earthen Levee
Item	Crown Surface / Depressions / Rutting
Looking south at depression greater than 6" on waterside shoulder.	
richard_f_20130930_954.jpg

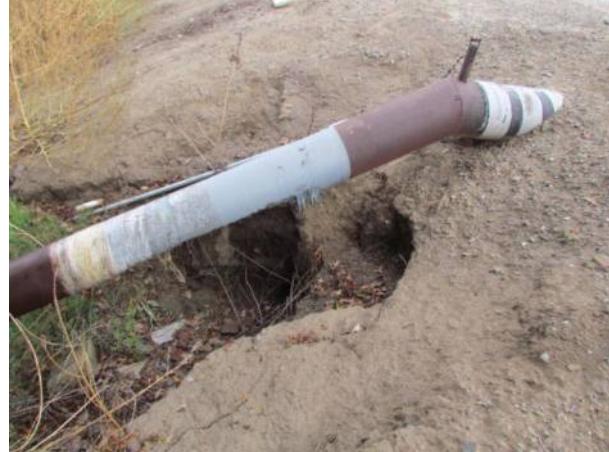
Levee Mile Report Line	67
Start Levee Mile	4.75
End Levee Mile	4.75
Location	Land Side
Category	Earthen Levee
Item	Slope Stability
Looking north at erosion around irrigation pipe on landside	
richard_f_20130930_939.jpg

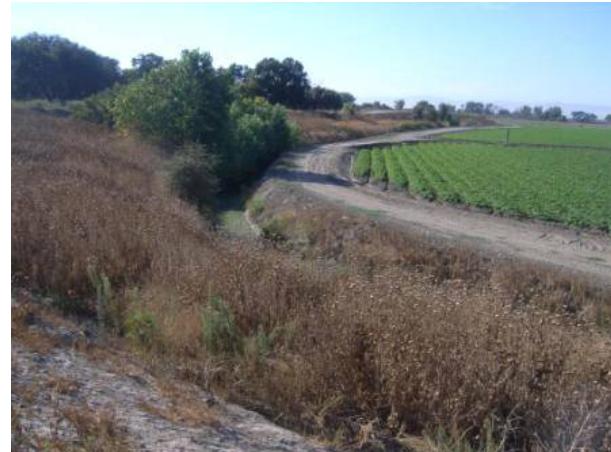
Levee Mile Report Line	74
Start Levee Mile	4.96
End Levee Mile	5.05
Location	Land Side
Category	Earthen Levee
Item	Encroachments
Looking southwest at ditch on landside slope and toe.	
richard_f_20130930_962.jpg

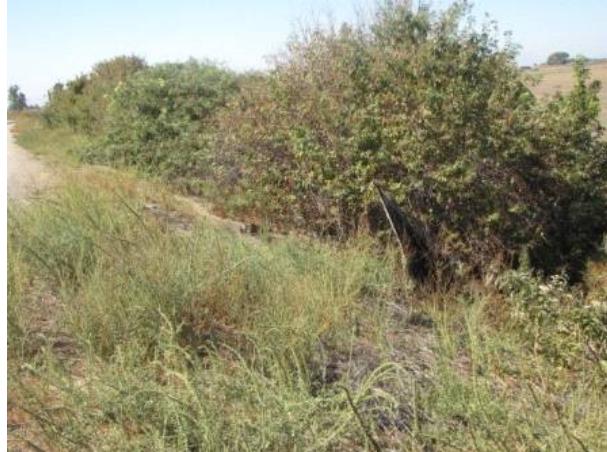
Levee Mile Report Line	78
Start Levee Mile	5.54
End Levee Mile	5.60
Location	Land Side
Category	Earthen Levee
Item	Vegetation
Looking south at elderberries on landside slope and toe.	
richard_f_20130930_936.jpg

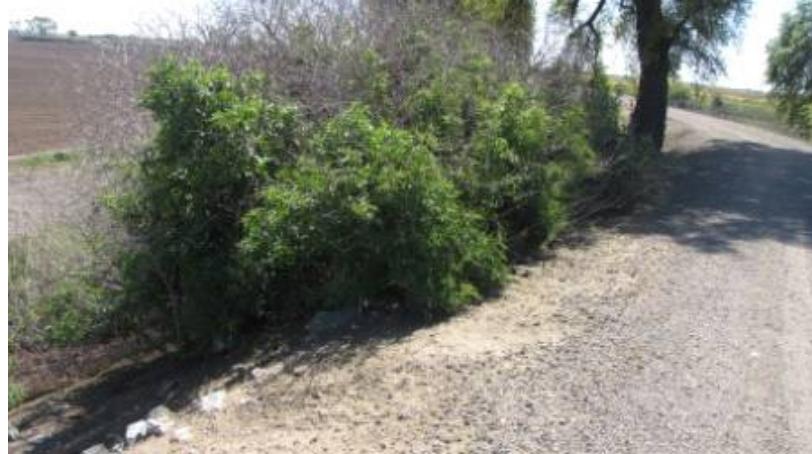
Levee Mile Report Line	2
Start Levee Mile	0.41
End Levee Mile	0.41
Location	Land Side
Category	Earthen Levee
Item	Vegetation
Looking northwest at elderberries on landside slope and toe.	
richard_f_20130930_963.jpg

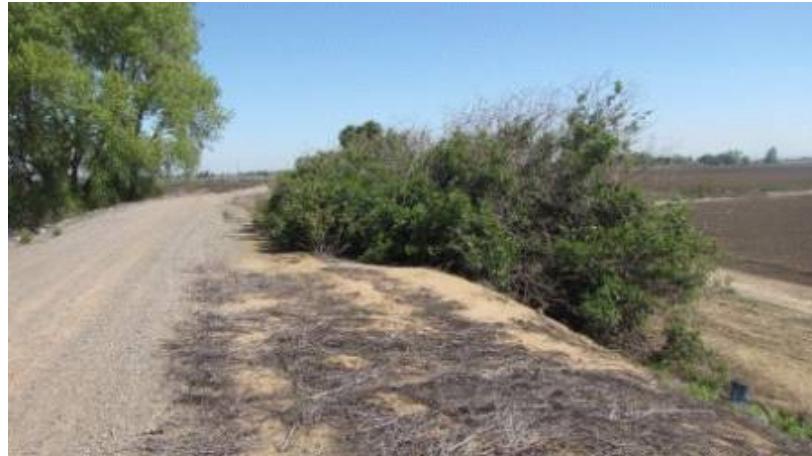
Levee Mile Report Line	6
Start Levee Mile	0.74
End Levee Mile	0.74
Location	Land Side
Category	Earthen Levee
Item	Vegetation
Looking south at elderberries on landside slope and toe.	
richard_f_20130930_966.jpg

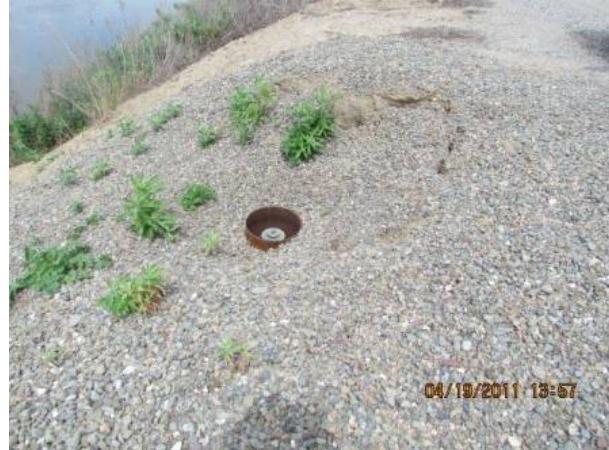
Levee Mile Report Line	7
Start Levee Mile	0.79
End Levee Mile	0.79
Location	Water Side
Category	Interior Drainage & Piping Systems
Item	Erosion Areas
Looking south at depression greater than 6" on waterside shoulder.	
richard_f_20130930_970.jpg

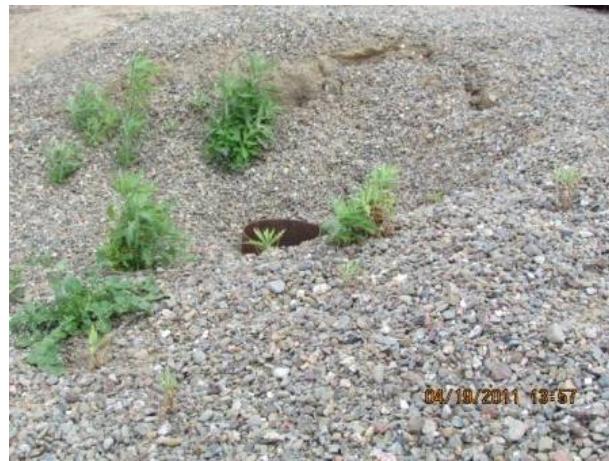
Levee Mile Report Line	7
Start Levee Mile	0.79
End Levee Mile	0.79
Location	Water Side
Category	Interior Drainage & Piping Systems
Item	Erosion Areas
Looking south at depression greater than 6" around siphon on waterside shoulder.	
richard_f_20130930_971.jpg

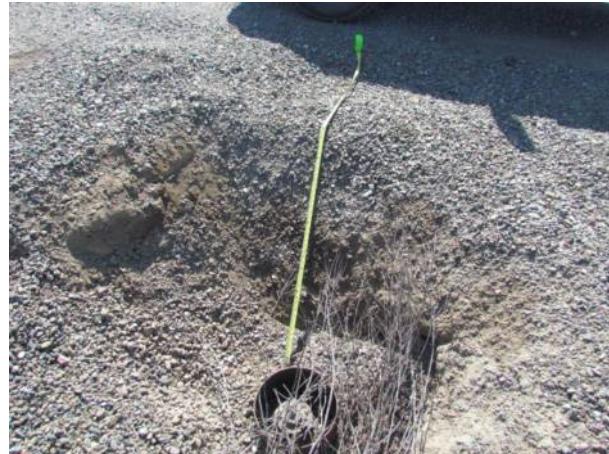
Levee Mile Report Line	7
Start Levee Mile	0.79
End Levee Mile	0.79
Location	Water Side
Category	Interior Drainage & Piping Systems
Item	Erosion Areas
Looking west at caving around siphon on waterside shoulder. (Spring 2012)	
richard_f_20130930_973.jpg

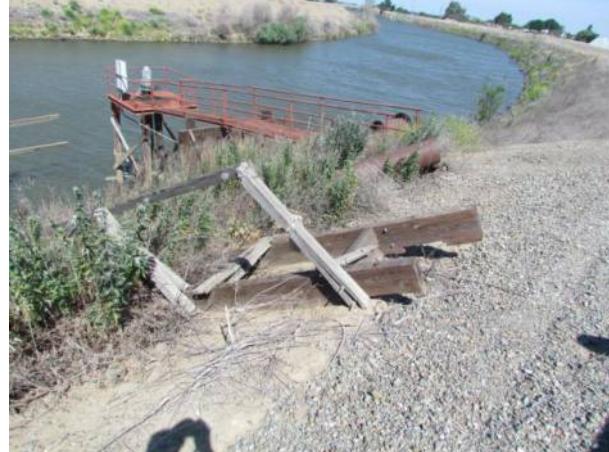
Levee Mile Report Line	8
Start Levee Mile	1.02
End Levee Mile	1.02
Location	Water Side
Category	Earthen Levee
Item	Encroachments
Looking southeast at garbage on waterside shoulder and slope.	
richard_f_20130930_967.jpg

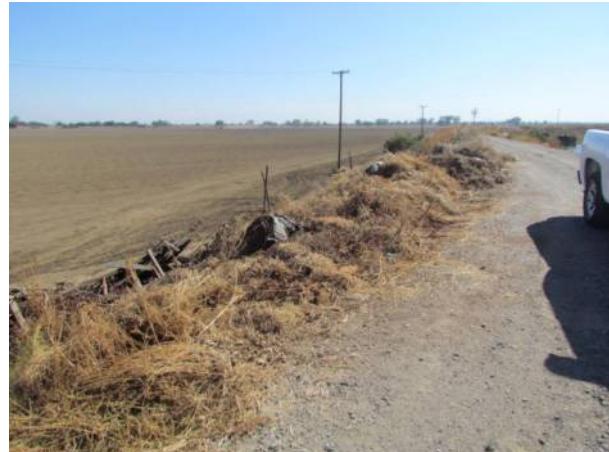
Levee Mile Report Line	9
Start Levee Mile	1.14
End Levee Mile	1.14
Location	Land Side
Category	Earthen Levee
Item	Encroachments
Looking west at prunings and grass clippings on landward slope.	
richard_f_20131030_144.JPG

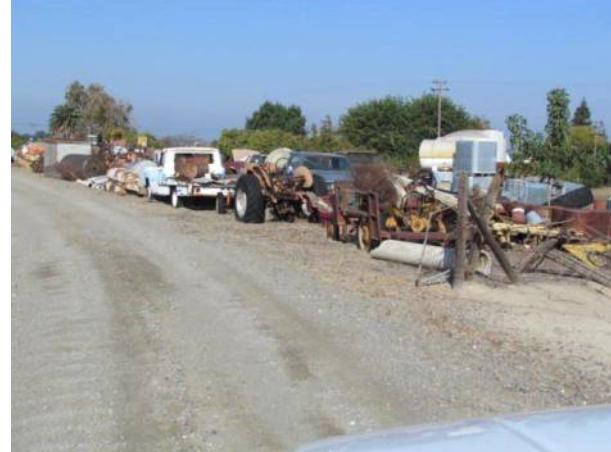
Levee Mile Report Line	11
Start Levee Mile	1.17
End Levee Mile	1.23
Location	Land Side
Category	Earthen Levee
Item	Encroachments
Looking southwest at farm equipment, vehicles, and other items stored on landside landing.	
richard_f_20130930_992.jpg

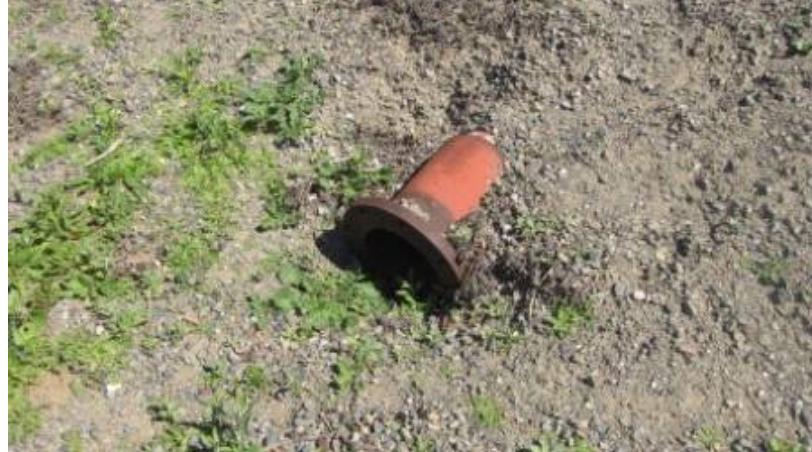
Levee Mile Report Line	15
Start Levee Mile	1.40
End Levee Mile	1.40
Location	Land Side
Category	Earthen Levee
Item	Encroachments
Looking west at east end of pipe on waterside slope.	
richard_f_20130930_997.jpg

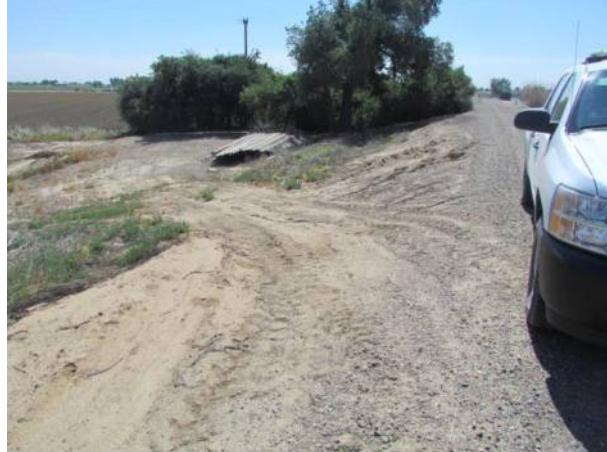
Levee Mile Report Line	17
Start Levee Mile	1.44
End Levee Mile	1.44
Location	Land Side
Category	Earthen Levee
Item	Slope Stability
Looking northwest at slope damage caused by vehicle traffic.	
richard_f_20130930_998.jpg

DWR ID: DWR_RD0544_02_s_2012_10
17	1.44	1.44	Earthen Levee	Slope Stability	LS Ma	M	S2 : Repair the levee slope damaged by foot traffic and prevent access where possible.	37.821697 ° -121.338397 °	37.821697 ° -121.338397 °	22	
											DWR ID: DWR_RD0544_02_s_2012_22
18	1.47	1.47	Earthen Levee	Animal Control	WS Ma	M	A1 : Exterminate rodents and backfill and compact or grout burrows.	37.821954 ° -121.338715 °	37.821954 ° -121.338715 °	28	
											DWR ID: DWR_RD0544_02_s_2012_28
19	1.48	1.48	Earthen Levee	Encroachments	LS En	M	TR : Tree or limb Inspector Comments: Dead tree and limbs should be removed from landside shoulder and slope.	37.822082 ° -121.338932 °	37.822082 ° -121.338932 °	23	
											DWR ID: DWR_RD0544_02_s_2012_23
20	1.55	2.11	Earthen Levee	Vegetation	WSA/W En	V2	: Remove the wild growth other than native grasses from the levee slopes.	37.820863 ° -121.341285 °	37.819393 ° -121.344428 °	26

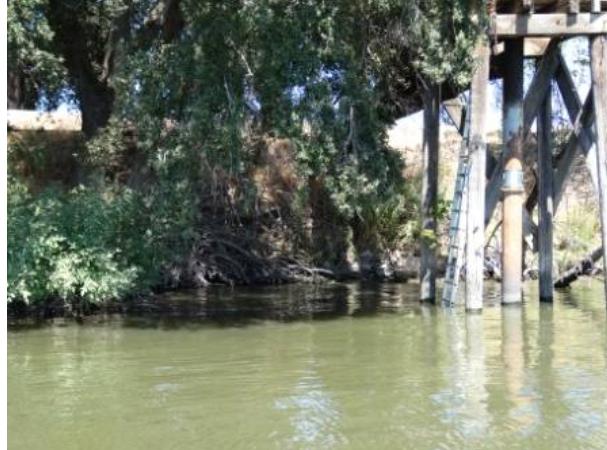
Levee Mile Report Line	28
Start Levee Mile	2.34
End Levee Mile	2.34
Location	Water Side
Category	Supplemental
Item	DWR Erosion Survey
Front view of the erosion site. View is partially blocked by the pump structure and vegetation.	
SJR2013_RD0544U02RM33.21_1.jpg

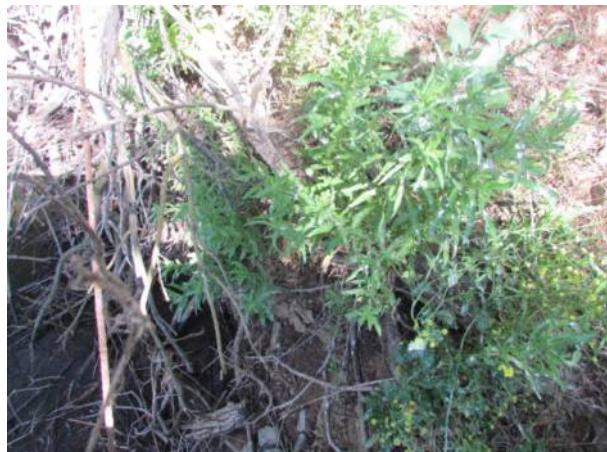
Levee Mile Report Line	29
Start Levee Mile	2.35
End Levee Mile	2.35
Location	Water Side
Category	Channels
Item	Erosion / Bank Caving
Looking south at breaver hole at waterside toe.	
richard_f_20130930_000.jpg

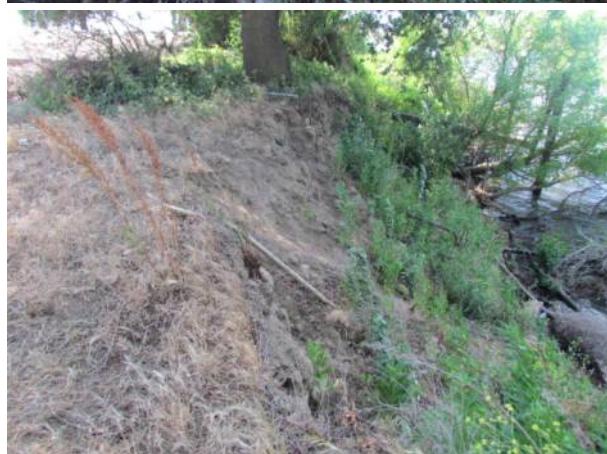
Levee Mile Report Line	29
Start Levee Mile	2.35
End Levee Mile	2.35
Location	Water Side
Category	Channels
Item	Erosion / Bank Caving
Looking north at erosion on waterside slope.	
richard_f_20130930_001.jpg

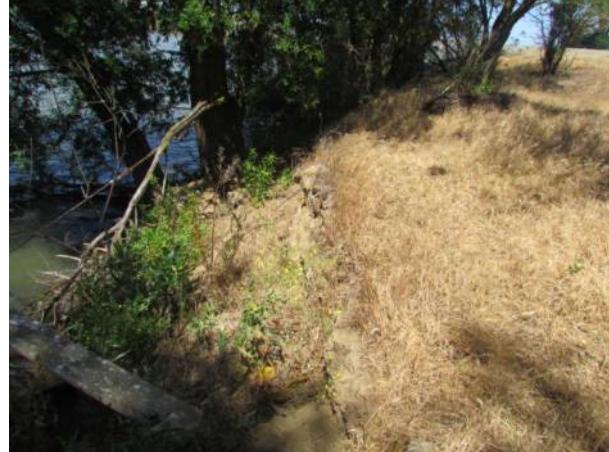
Levee Mile Report Line	29
Start Levee Mile	2.35
End Levee Mile	2.35
Location	Water Side
Category	Channels
Item	Erosion / Bank Caving
Looking south at river erosion at waterside toe near pumping station.	
richard_f_20130930_002.jpg

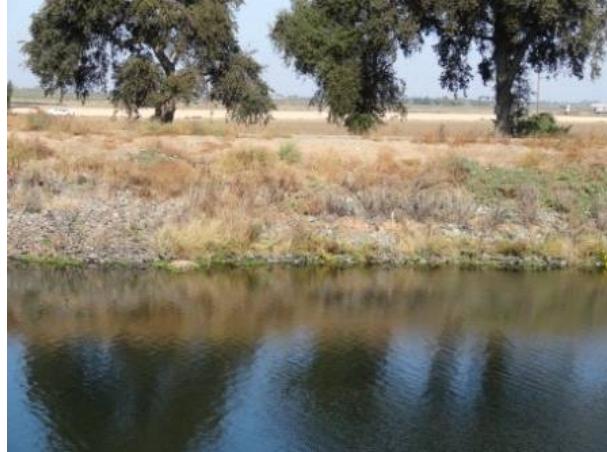
SJR2013_RD0544U02RM32.91_1.jpg

Front view of pocket erosion. Note the vegetation and riprap at the site.

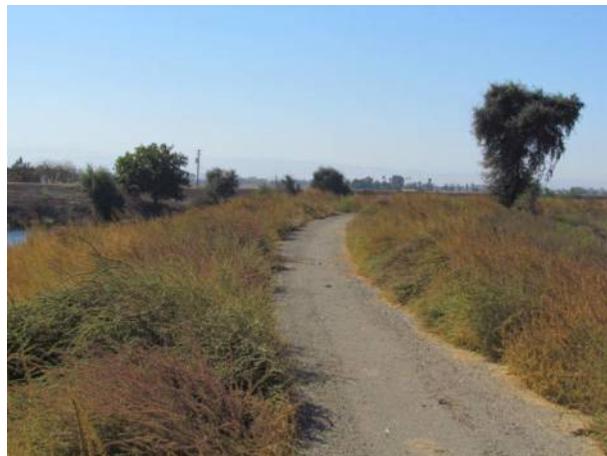
richard_f_20131030_146.JPG

Levee Mile Report Line	35
Start Levee Mile	2.76
End Levee Mile	3.23
Location	Land Side
Category	Earthen Levee
Item	Vegetation

Looking south a dense vegetation on landward and waterward slope.

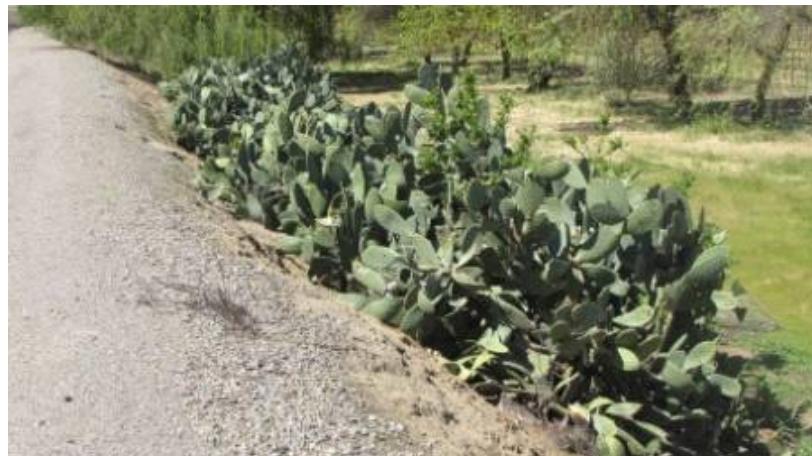
richard_f_20130930_003.jpg

Levee Mile Report Line	37
Start Levee Mile	3.53
End Levee Mile	3.56
Location	Land Side
Category	Earthen Levee
Item	Vegetation

Loooking southwest at overgrown cactus on landside slope.

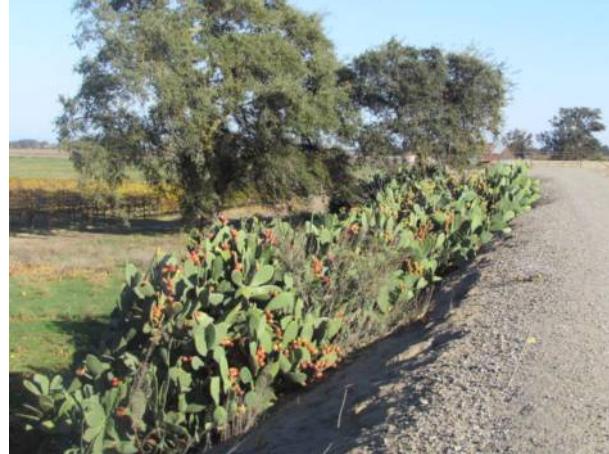
Levee Mile Report Line	37
Start Levee Mile	3.53
End Levee Mile	3.56
Location	Land Side
Category	Earthen Levee
Item	Vegetation
Looking north at cactus on landside slope and toe.	
richard_f_20130930_004.jpg
